Failure analysis of a degraded 1.2 kV SiC MOSFET after short circuit at high temperature

Failure Analysis of a Degraded 1.2 kV SiC MOSFET after Short Circuit at High Temperature

Paula Diaz Reigosa, Francesco Iannuzzo, Lorenzo Ceccarelli

Department of Energy Technology, Aalborg University, Pontoppidanstraede 111 DK-9220, Denmark

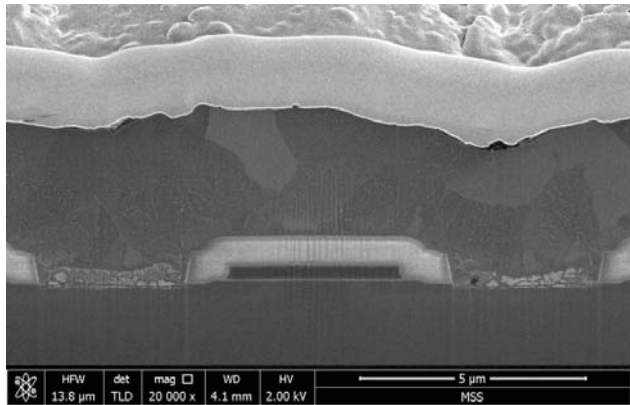
Fig. 8. Zoomed view of the FIB cross-section of a new SiC MOSFET.

the passivation layer shows a significant degradation between the non-degraded cell and the degraded one, since this layer appears to be deformed. From these results, it can be inferred that the temperature reached during short circuit provokes the deformation of the cells that could lead to the formation of cracks in the upper oxide region. These deformations

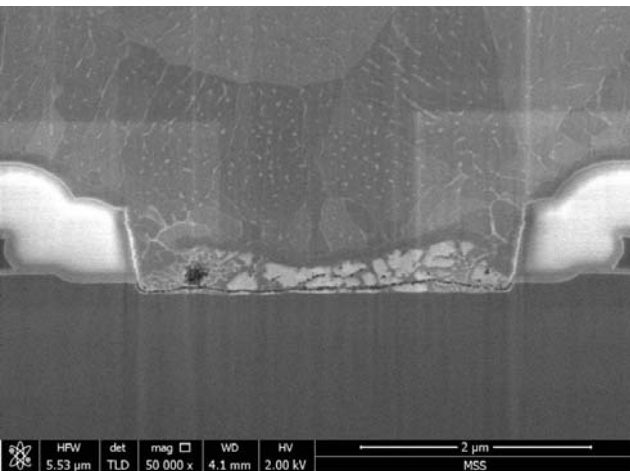
Furthermore, the salicide which is the technology that is used to form the electrical contact between the semiconductor substrate and the source terminal appears severely degraded, as pointed out in Fig. 5. This region is further magnified in Fig. 6, where it can be observed that solid particles accumulate in the aluminum source region between the salicide and the gate oxide. So far, the origin of these particles is not clear and it is not possible to provide the relevant information about the failure mechanism due to the short circuit stress. To better understand whether these particles may come from a process defect or could have originated after the applied short circuit stress, a cross-section of a new 1.2-kV/90-A SiC MOSFET will be presented in the next section.

Fig. 9. Magnified Focused Ion Beam (FIB) of the salicide region of a new SiC MOSFET.
